DOT/FAA/AR-95/49

A Study of the Continued Fire Worthiness of Aircraft Seat Cushion Fire-Blocking Layers

March 1997

Final Report

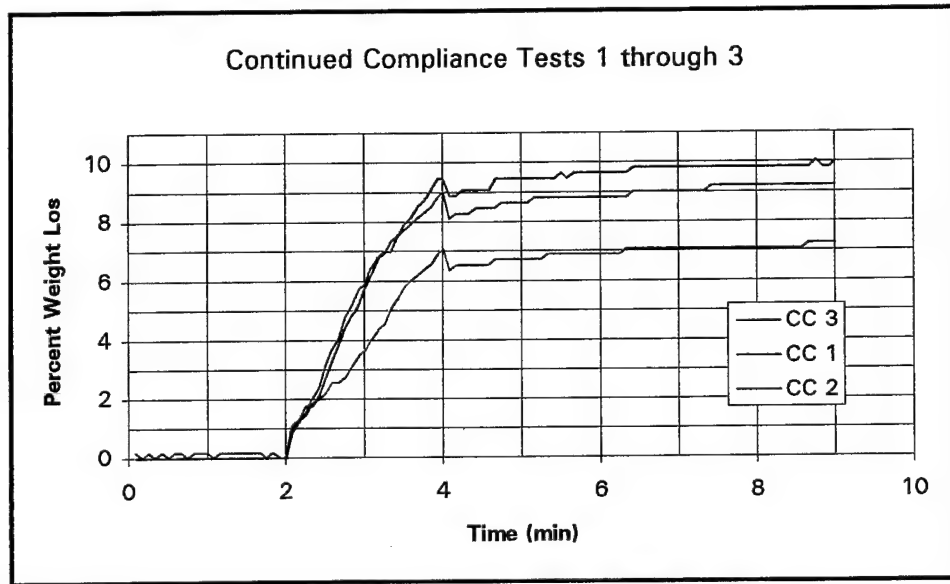
FIGURE 1. PERCENT WEIGHT LOSS PROFILES, TESTS 1 THROUGH 3

Stock Test Results. The weight loss profiles of the stock tests are shown in figures 1 and 2. The eight stock tests resulted in five tests exceeding 10 percent weight loss. The stock cushion tests did result in several instances where burn lengths exceeded the 17 inch (43.2 cm) requirement. In either case, the standard pass/fail criteria has no relevance in the stock configuration tests, which are expected to have higher test values. The data scatter was wide for both stock test series A and B, as seen in tables 4 and 5. Excluding test number five, no unusual fire behavior was observed during the testing.

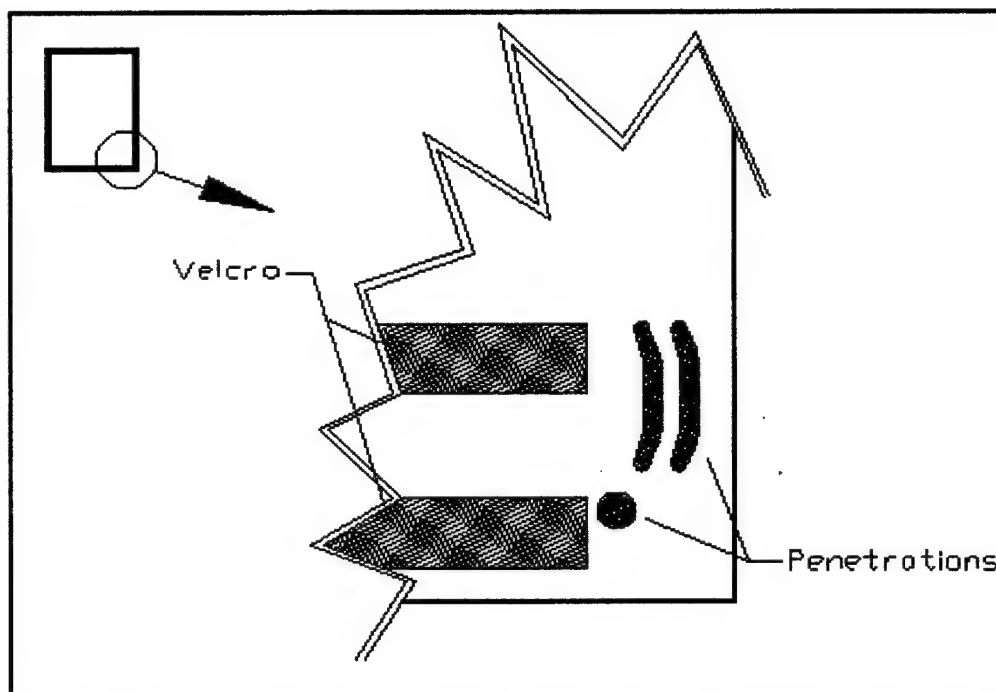
FIGURE 3. TEST NUMBER FIVE FIRE-BLOCKING LAYER PENETRATIONS
(vertical cushion, cutaway view of rear facing corner closest to burner cone)

Test number five resulted in a weight loss of 27.47 percent. Excessive damage resulted from penetrations in the vertical cushion FBL. The three penetrations were located on the back side bottom corner closest to the burner (see figure 3). They consisted of two, four-inch by one-half-inch (10.2-cm by 1.27-cm) vertical, parallel slashes with a separation of one inch (2.54-cm); and a one-inch (2.54-cm) -diameter hole located approximately two inches (5.08 cm) below and one inch (2.54 cm) to the side, opposing the burner, from the vertical slashes. During the portion of the test when the oil burner was turned off, burning originated from the backside of the cushion. This behavior was solely due to the FBL penetrations.

Test number five demonstrated the effect of FBL penetrations. The two, four-inch by one-half-inch (10.2-cm by 1.27-cm) slashes plus the one-inch (2.54 cm) -diameter circle, provide a total penetration area of 4.78 square inches (30.8 square centimeters). Several other cushions also had penetrations in differing spatial orientations which negated propagational behavior as seen in test number five. These penetrations, found in cushions tests 9, 11, and 33, were characterized as one-inch (2.54-cm) or less diameter holes being mechanically created by vibration and friction

from contacting rivet heads or other such features in the stock seat frame. The orientation of the burner flame to the penetration played the obvious factor regarding fire development.

Penetrations to the FBL must be considered very carefully beyond the scope of a standardized test. During this work, some threshold phenomena is evident when considering the successful or failed combustion of a seat cushion. The penetration orientation with respect to a flame, the surface area of the penetration, the seat cushion material(s) and construction, and the dynamics of the flame exposure impact this threshold behavior. In the case of test number five, the penetrations were not subject to direct flame contact. However, the size of the penetrations allowed acceptable ventilation inside the fire-blocking layer resulting in combustion of the foam cushion. The danger of penetrations is demonstrated by test number five. Yet, tests 9, 11, and 33 demonstrated smaller insignificant penetrations.

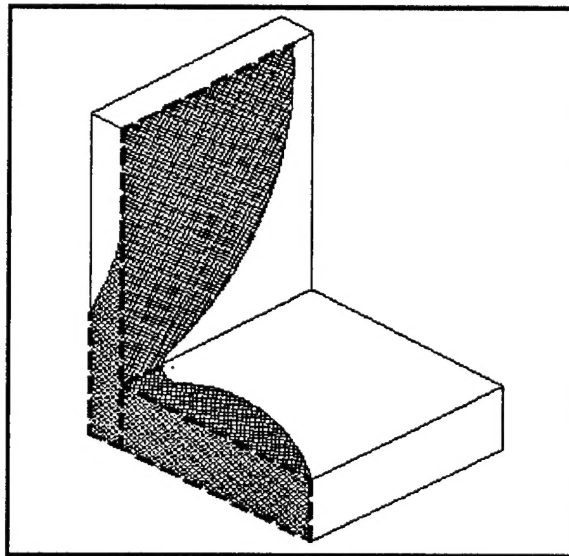
FIGURE 16. TYPICAL BURN PATTERN RESULTING FROM SEAT TEST
(typically damaged areas are cross-hatched)

The seat cushion tests, for the most part, followed a generic sequence of events. Upon flame impingement, the vertical edge of the horizontal cushion facing the burner lost its dress cover due to combustion. The flame also contacted the upper and lower horizontal cushion surfaces of the horizontal cushion near the burner cone. The burner flame also tracked in an upward arc across the front, vertical face of the vertical cushion. The arc started from the intersection of the horizontal and vertical cushions, close to the burner, and swept upward further away from the flame source. A typical burn pattern is shown in figure 16.

The dress cover material was consumed in these areas as well. The fire-blocking materials subjected to the oil burner flame were only affected in the flame contact zone and the immediate vicinity of the burner jet. The FBLs underwent a thermal degradation which resulted in a black, charred, brittle state. In many instances, a crack formed on the vertical cushion edge which received the direct flame contact. This crack had no further negative effect in the combustion of the cushion. Excluding the vertical edge facing the burner cone, the mechanical integrity of the FBL materials were never compromised due to flame impingement.
